Request for Qualifications / Proposals
for (1) Asbestos Containing Materials and Lead Based Paint
Abatement and (2) Mezzanine Demolition at 18242 Sherman
Way, CA 91335

Project Number: 1031951

Re: Limited Asbestos Containing Materials and
Lead-Based Paint Survey Report
Commercial Building
18242 Sherman Way
Reseda, CA 91335

Date Report Issued: April 3, 2023

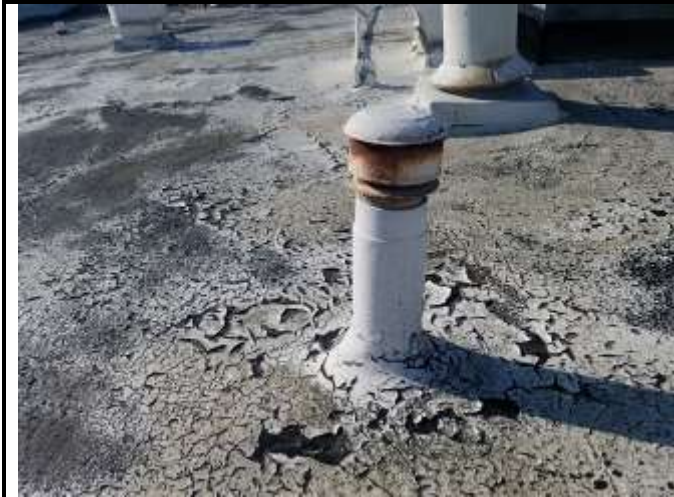
Photo 1: roof- transite vent pipes (ACM)

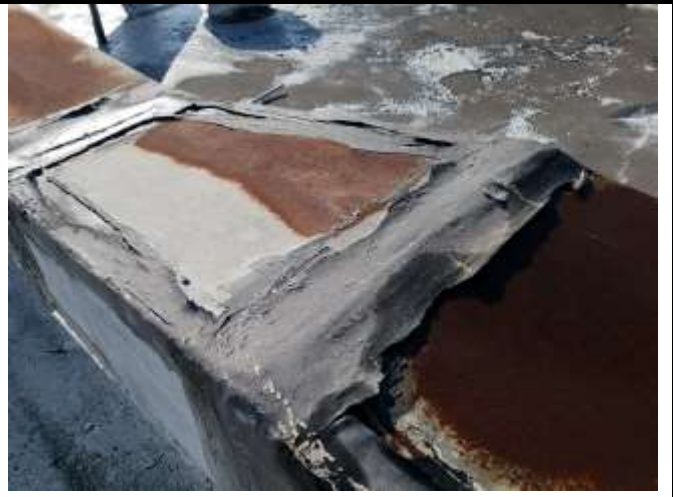
Photo 2: roof – mastic on HVAC ducts and penetrations (ACM)

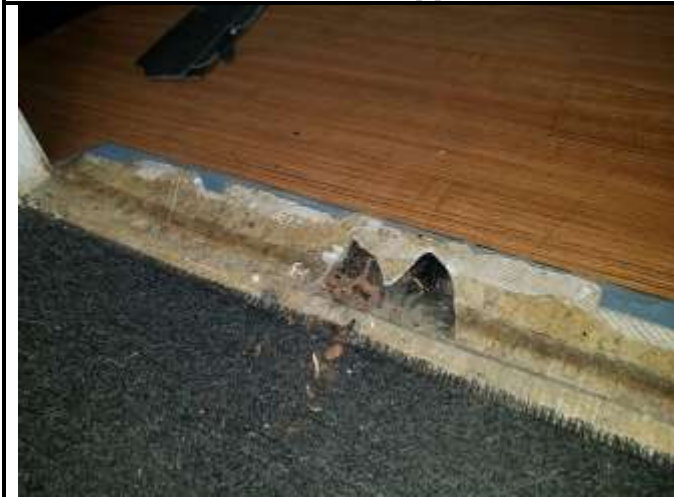
Photo 3: Women’s restroom floor – multilayer VFT (ACM)

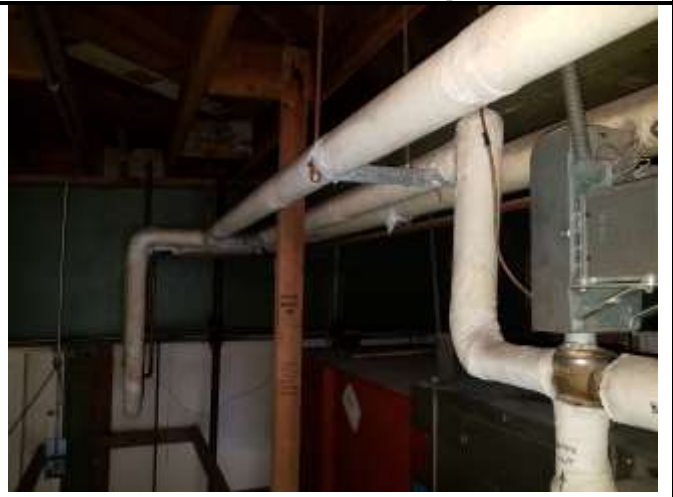
Photo 4: Attic/loft TSI pipe insulation (ACM)

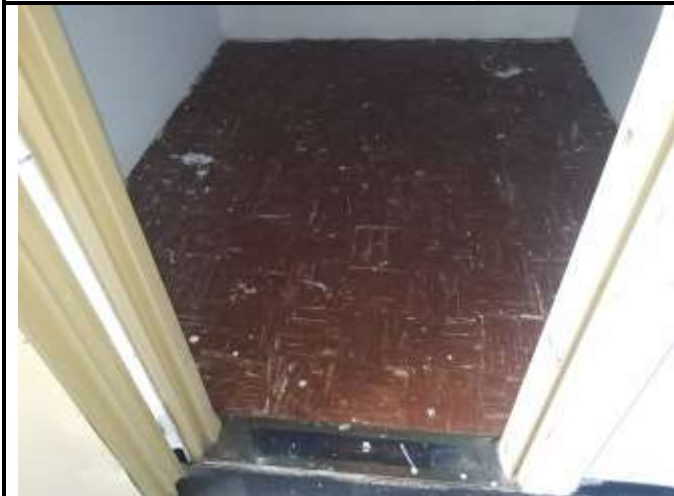
Photo 5: 2nd floor vault and storage - brown 9”x9” VFT (ACM)

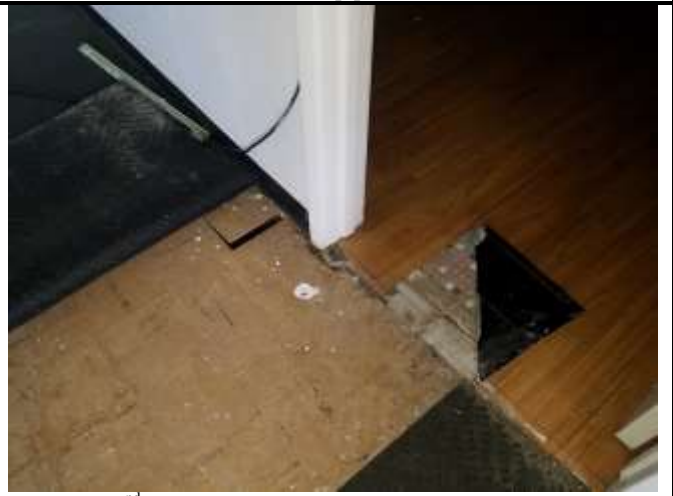
Photo 6: 2nd floor main room and men’s bathroom – 9”x9” VFT (ACM) and ceramic floor tile (LBP)

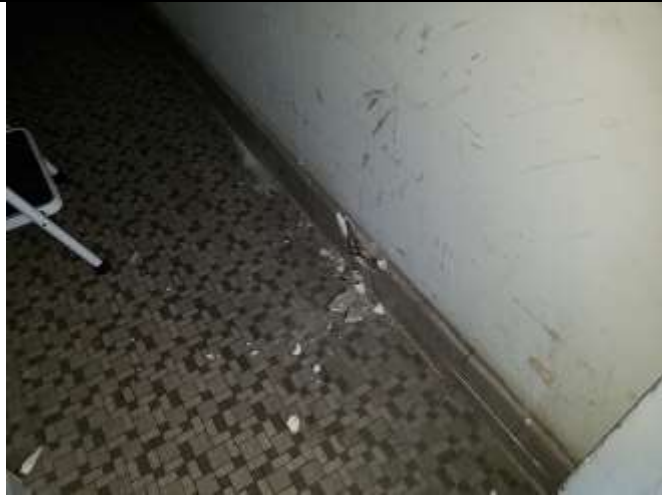
Photo 7: 1st floor storage/electrical room wall and floor ceramic tile (LBP)

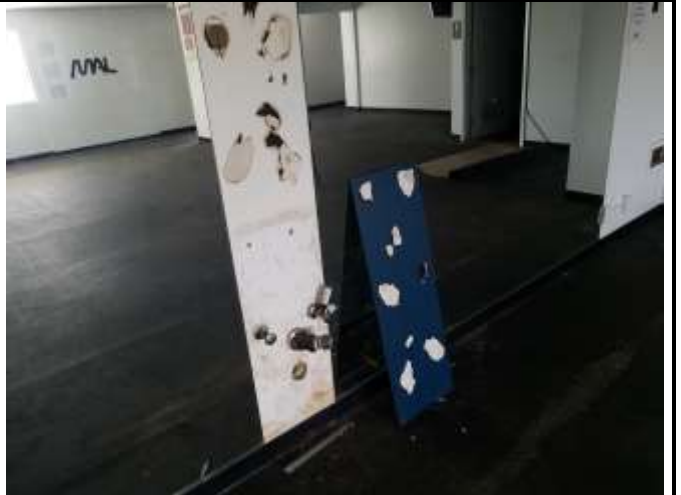
Photo 8: mirror mastic (ACM)

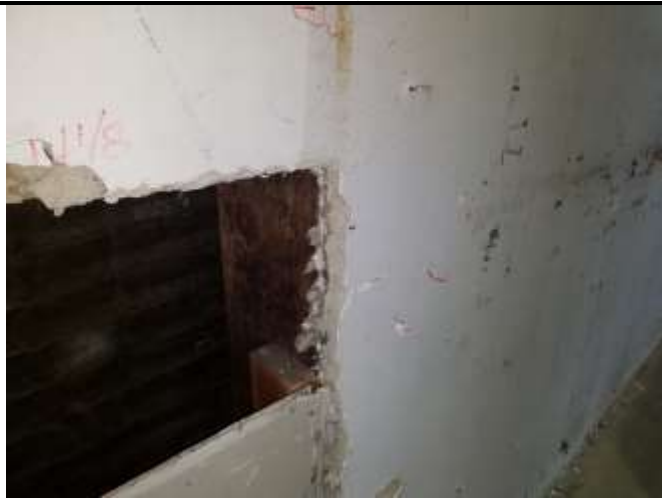
Photo 9: plaster system (non-ACM)

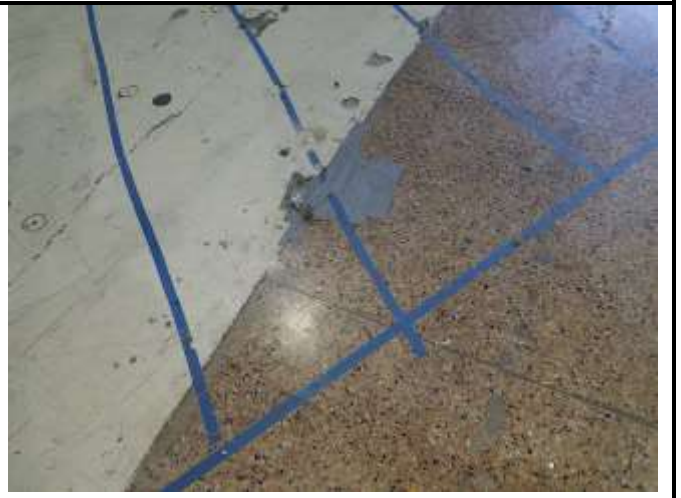
Photo 10: terrazzo/concrete (non-ACM)
